Restoring the Northern Pacific Water Tank at Elkhorn MT

Northern Pacific Water Tank

Summer 2017 Restoration

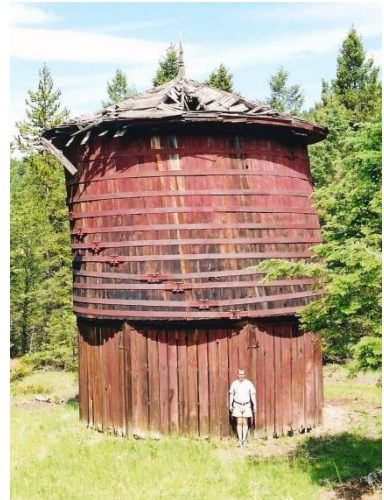
On the southern flank of Elkhorn Mountain, 20 miles southeast of Helena, a railway water tank is clinging to life 127 years after its initial construction. The water tank was built by the Northern Pacific Railroad in 1890 to serve the silver mining boomtown of Elkhorn. Replenishing the steam locomotives with water was critical after they battled the 4% grade up to Elkhorn. Along with the water tank, a depot and other facilities served the railroad from 1890 to 1914. After that, the town of Elkhorn used the water tank for an undetermined number of years. Today the tank resides on private land just north of town and it can be viewed from the road which travels north beyond Elkhorn.

The tank is significant in several respects. Bill Taylor, noted Montana railway historian, is unaware of any original NPR water tanks like this that still survive. Typically, water tanks were dismantled in the 1950s and 1960s after steam engines were replaced with diesel locomotives. The Elkhorn water tank is not only the oldest water tank in the region, but it is *the only* known remaining NPR Standard Plan 48,000 gallon water tank of that era known to still exist. Note in the picture the very wide horizontal bands, the large planks on the lower tank, and the conical roof with its decorative finial. The tank was built to last and its longevity is a testament to its heavy duty construction.
